Strengthening of corrosion damaged RC beams by ferrocement composite laminates

Balakrishna MN¹✉, Fouad Mohammad², Robert Evans², Rahman MM²

Balakrishna MN, Fouad Mohammad, Robert Evans, Rahman MM. Strengthening of corrosion damaged RC beams by ferrocement composite laminates. *Indian Journal of Engineering*, 2018, 15, 79-90

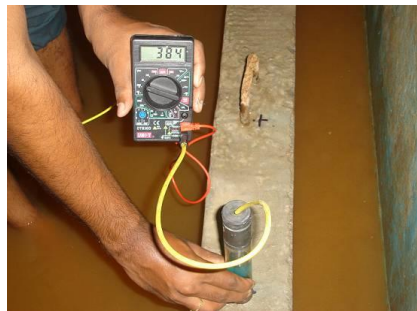
**Figure 3** View of corrosion monitoring

The reinforced concrete beams were subjected to an accelerated corrosion process in an electrolytic cell by means of a direct current supply. An electric current was passed through the main longitudinal bottom reinforcing bars of about maximum 5000 mA. The beams were placed on the stainless steel plate SS316 grade acting as a cathode (Non-corrosive plate) and this set up was placed in the 3.5% NaCl solution, which acted as an electrolyte and the solution level in the tank was adjusted to slightly exceed the concrete cover plus rebar diameter in order to ensure adequate submission of longitudinal reinforcement. The layout of corrosion monitoring setup is shown in the Fig.3 It is possible to convert the current flow to metal loss by Faraday's second law. According to Faraday's law, the time for accelerated corrosion was calculated as 95.96 hours for 10% mass loss (corrosion) of tension steel.

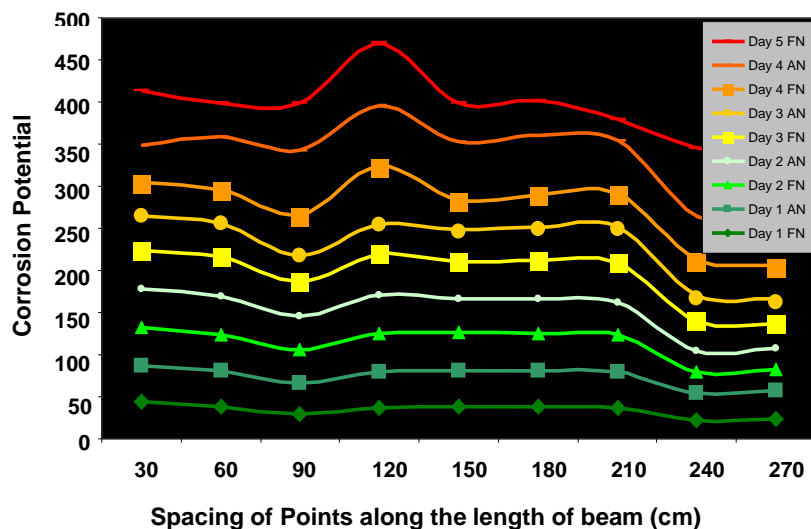
**Figure 4** Corrosion potential Vs Time

The corrosion process causes electrical potential to be generated, where as the half-cell provides method of detecting these electrical potentials. The half cells consist of an electrode of a metal contained in an electrolyte consisting of a saturated solution of one of its own salts. Copper in copper sulphate and silver in silver chloride are commonly used. A porous plug in the end of the cell allows the electrolyte to make contact with concrete surface. The half-cell provides a reference against which corrosion potentials of steel in concrete can be measured. Corrosion activity on the reinforcement will cause a change in the potential generated by the copper cell. The half cell is moved to different locations on the concrete surface, usually in a grid pattern and the potential in millivolts at each location is noted. Using the half cell potential setup, potential readings were taken along the length of the beam at a uniform distance to monitor the progress of corrosion process. The potential readings were taken two times per day and plotted a graph of corrosion potential value versus time as shown in Fig.4. After the accelerated corrosion process the beam specimens were taken for rehabilitation.

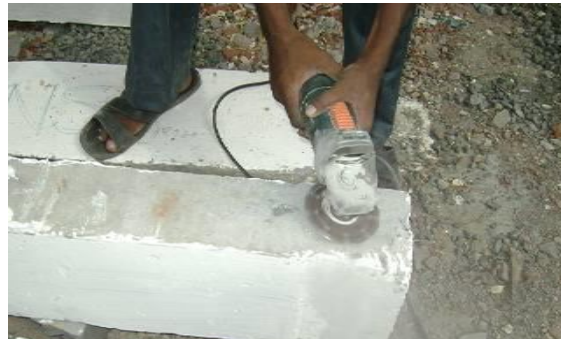
Figure 5 Surface preparation

The damaged beams were arranged with its tension side facing upwards for surface preparation, corrosion repair and for bonding work as shown in Fig.5. Prior to bonding of laminates, tension side of the beams was grinded to remove the surface laitance and to expose the rough surface. After surface preparation, the cracks were filled by a low viscous resin grouting. Then the adhesive components were mixed thoroughly and applied to the surfaces using trowel and then ferrocement laminates were placed in position. After bonding of laminates, the test specimens were kept for atmosphere curing for 7 days. During this period the specimens should not be disturbed and the environment should be free from moisture.

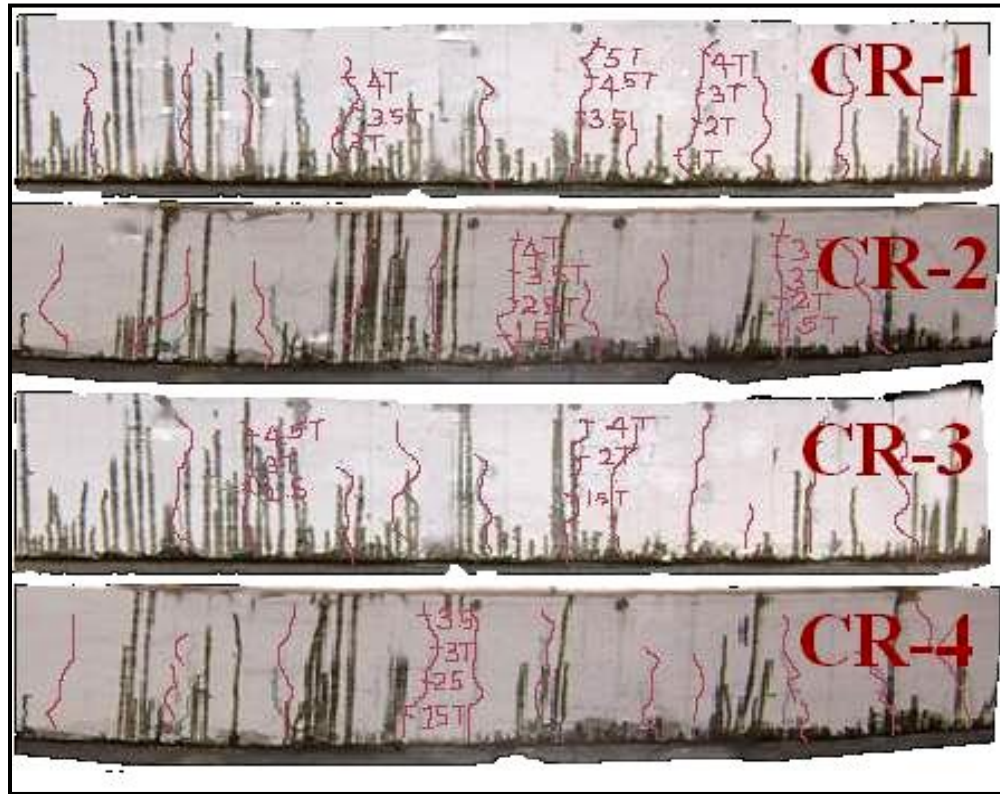
Figure 6 Crack pattern of perfect and corrosion control beams

The cracking patterns of the perfect and retrofitted beams after testing are shown in the following Fig.6. Similarly load-deflection
